Northland Rail Programme

June/July 2024

Progress repairing the North Auckland Line

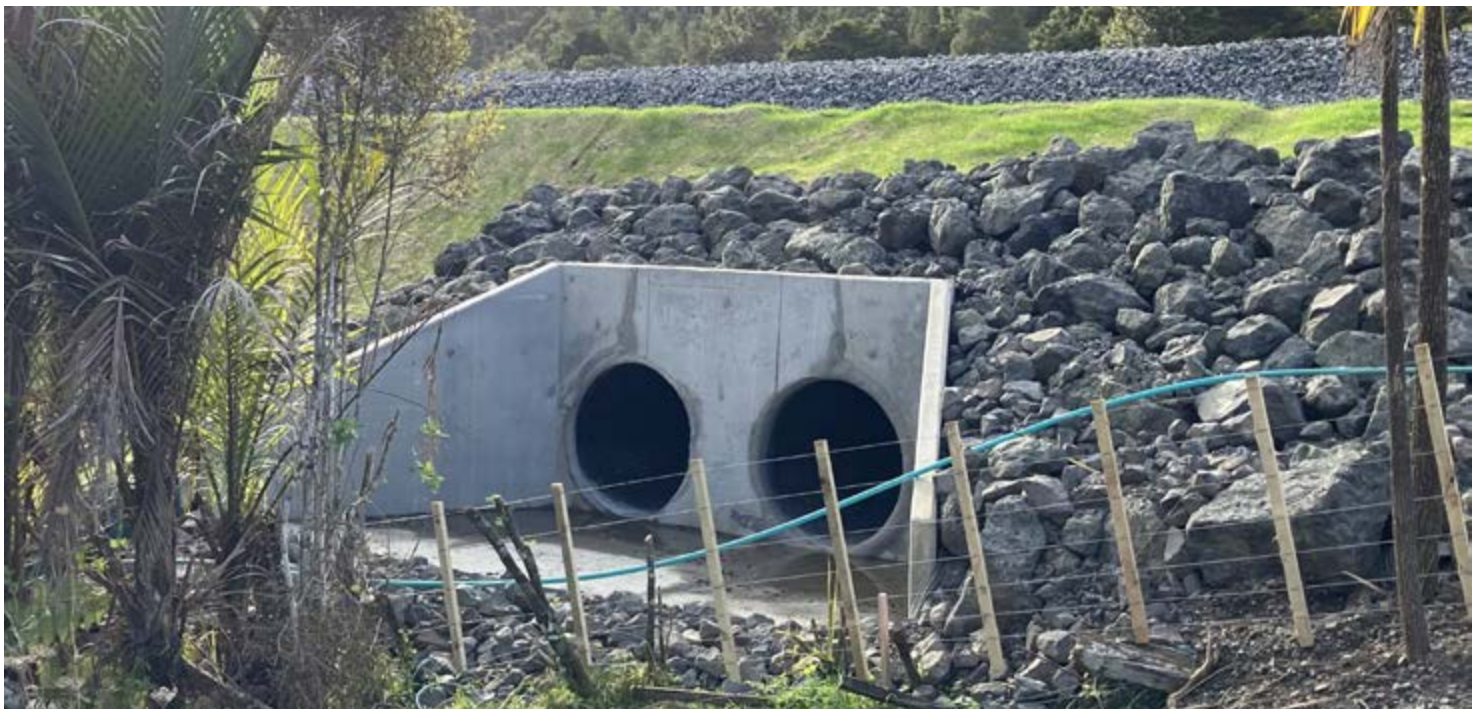
An example of drainage improvement near the 93km mark in the Ahuroa Valley. Installing larger culverts helps protect the line from being washed away in future weather events.

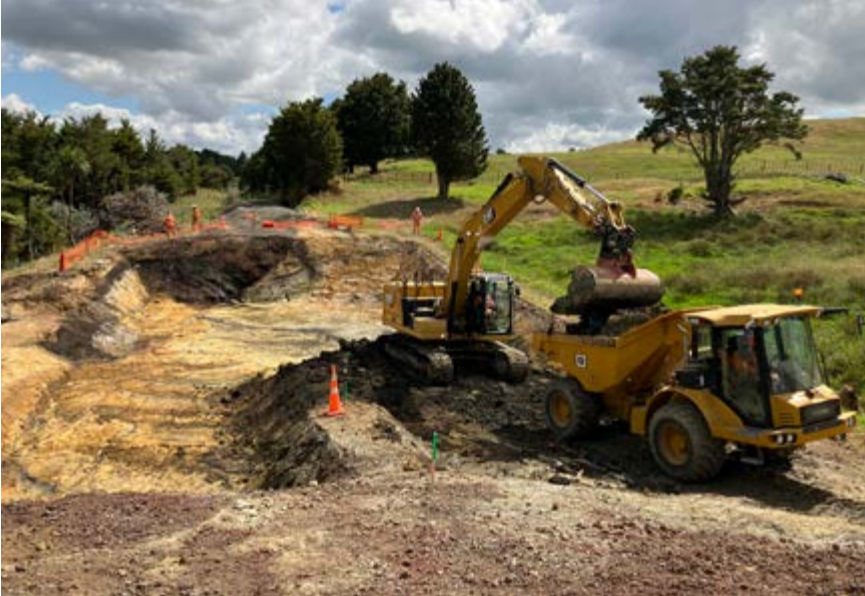
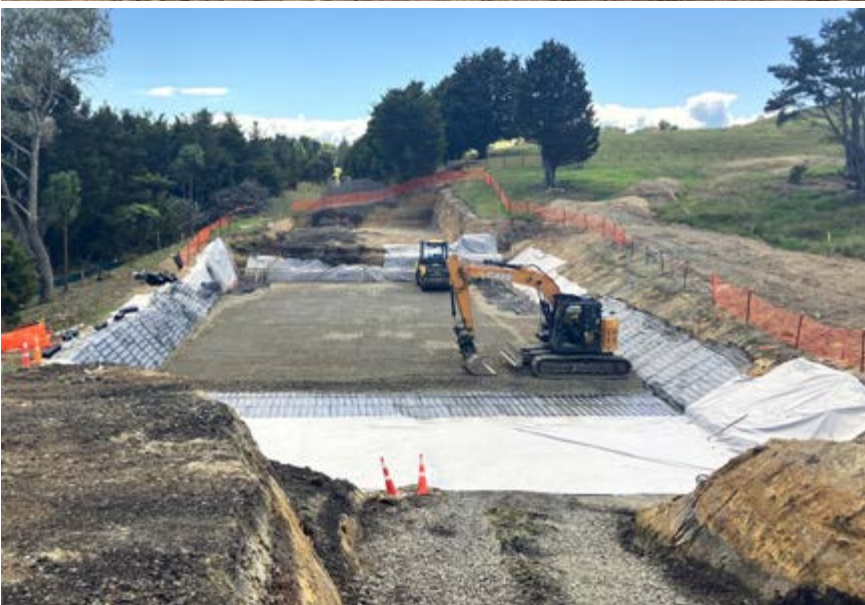
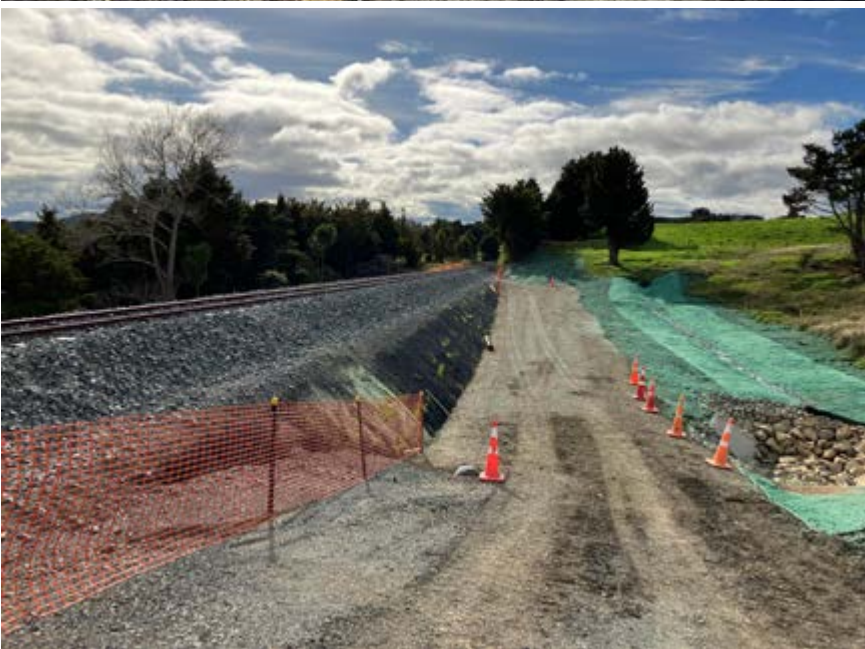
Progress repairing the major 185km damage site, south of Tauraroa. This is an example of Northland's slip prone geology, where a gentle hillside slumped under the rail line. It has required major excavation and drainage work beneath the rail embankment, which was rebuilt with sturdier materials.

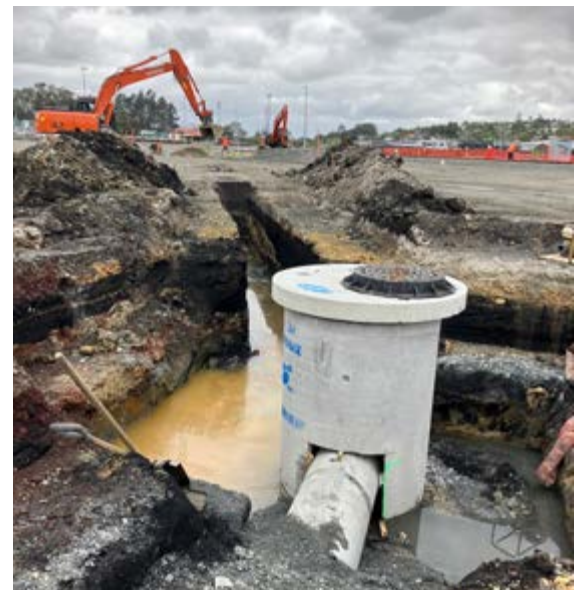
Drainage improvement work going on at the Whangārei rail yard.

Work has also been completed upgrading the track in the Whangārei Rail Yard to take 18-tonne axle loads and work has commenced to reconstruct the hardstand surface of the container terminal. We are also doing work to improve drainage and flood management in the yard, which will help protect the surrounding community. As with the upgrade work to Kauri, getting this work done before the NAL reopens reduces any further disruption for customers.

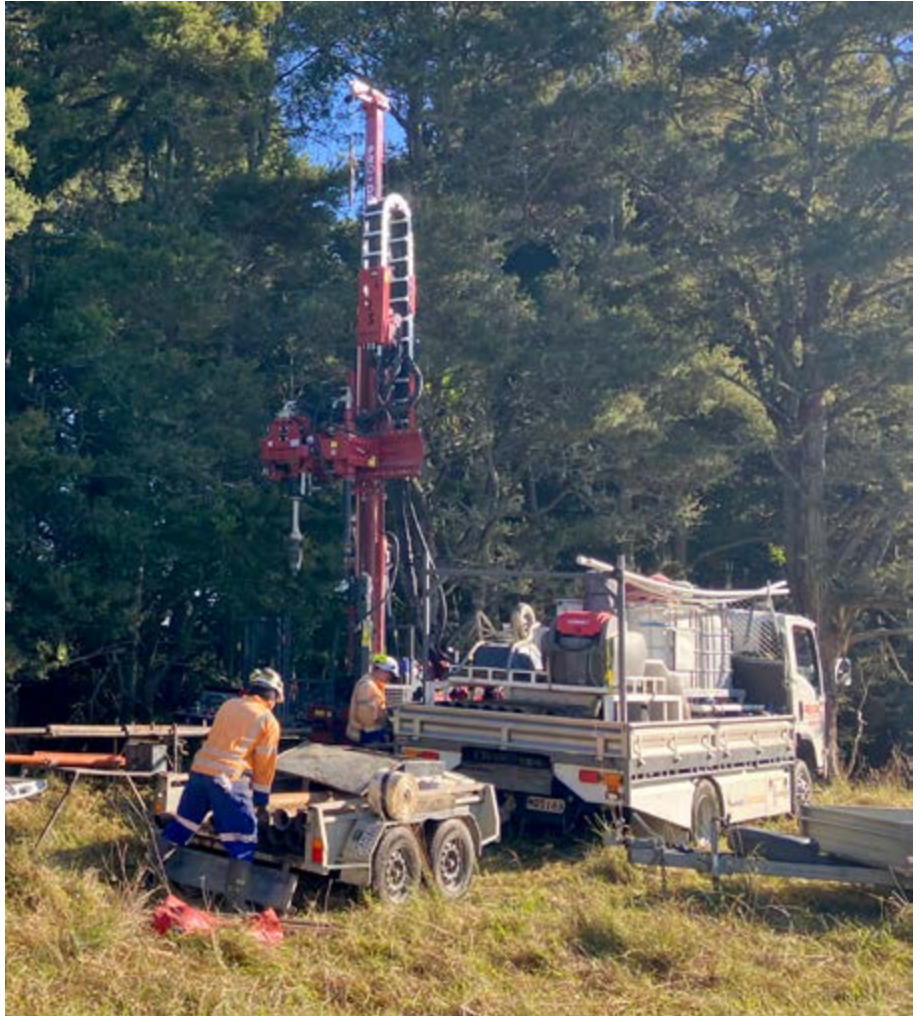
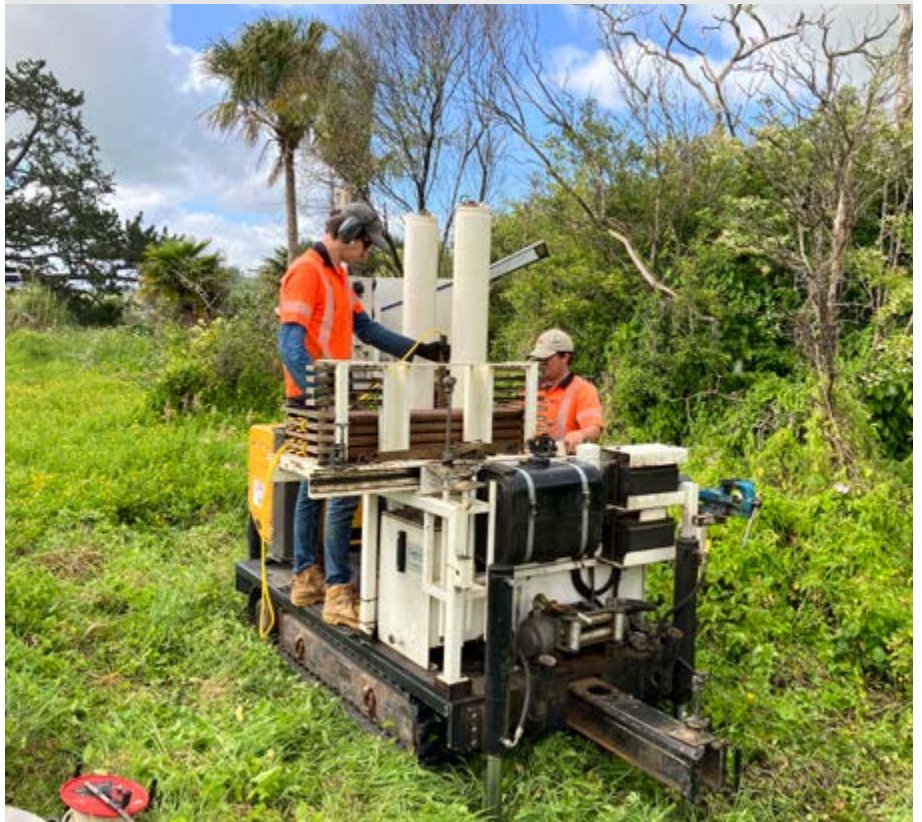
Above: core drilling near Flyers Road on the Marsden Point Rail Link route, to understand the geology. Below: ground testing at Oakleigh
