Wairarapa SW Carriage Rough Ride and Vibration Review

Planning, Delivery and Tolerances

Prepared for KiwiRail and Greater Wellington Regional Council

Prepared by Beca Limited

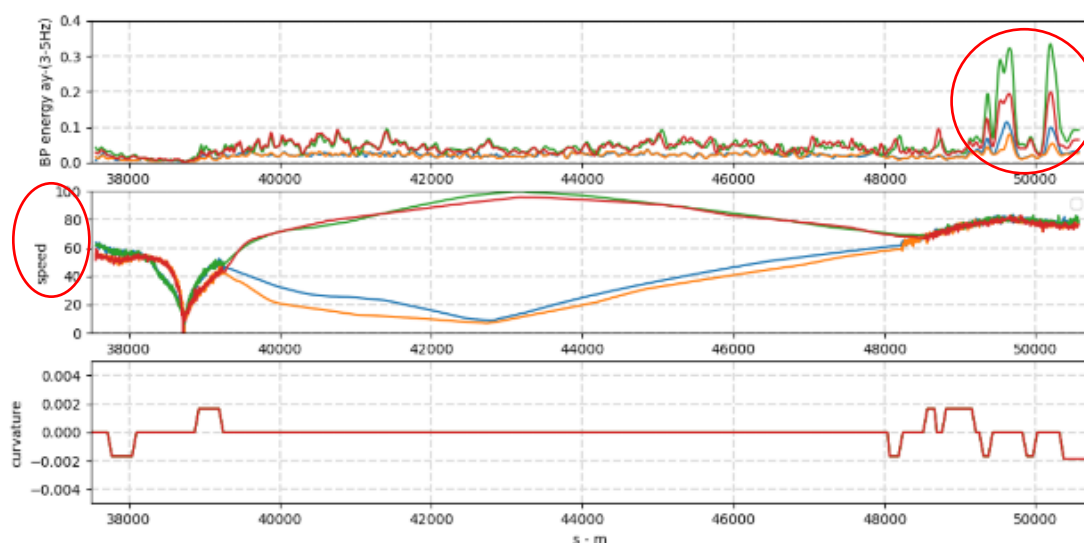
Figure 3. Data logger information recording hunting at ~49km at 80km/hour

Data loggers placed in four carriages have been measuring the actual forces generated in the carriages (Figure 3). Varying locations were identified within the carriages for data loggers to be installed, which also confirmed increased forces measured directly above the bogies versus loggers located in the centre of the carriage.

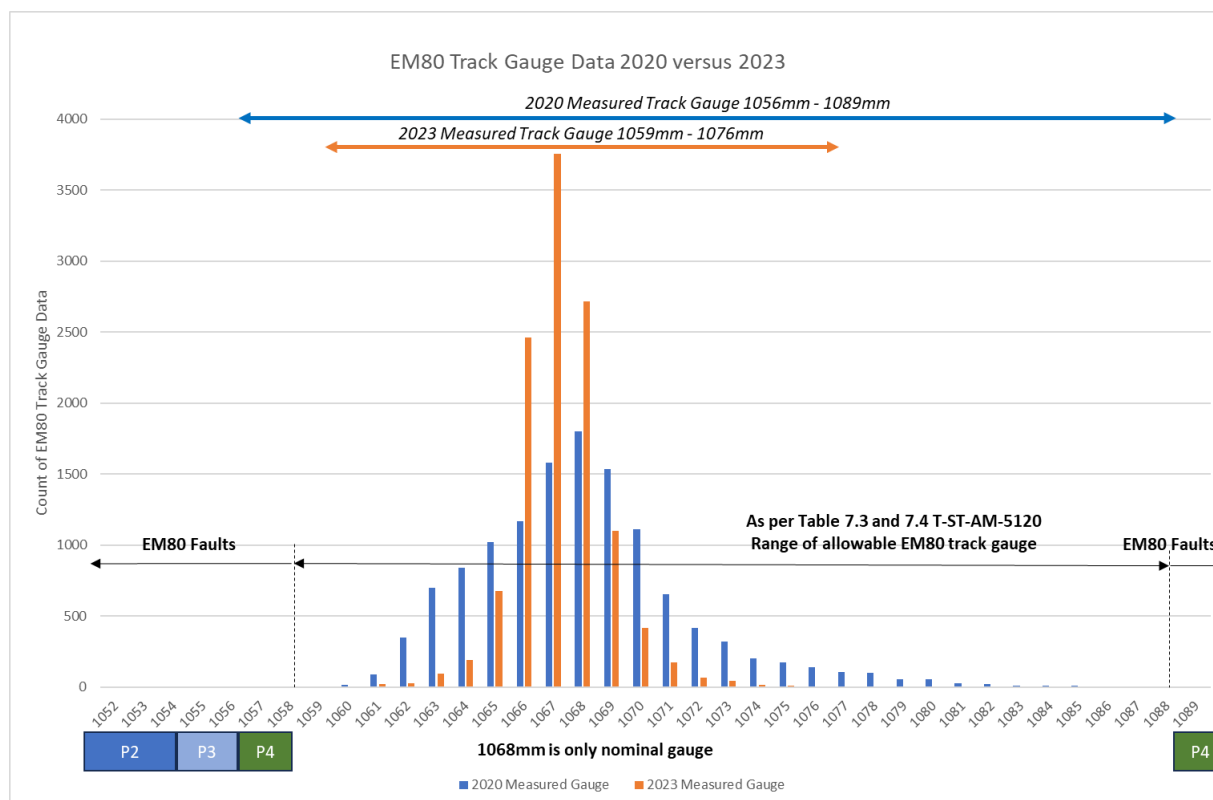
Figure 7. 2020 April EM80 versus 2023 December EM80 track gauge ranges, including EM80 defect notification tolerance and P ratings (as per T-ST-AM-5120 Track Standard: Track Geometry)

The quantum of catch-up renewals, shown in Figure 7, has achieved a 32% improvement on nominal gauge variability (1066mm-1070mm) from 2020 to 2023, with EM80 data revealing:

- 2020 track gauge had more variability, including more sections that are less than 1066mm, and some that are significantly greater than 1070mm. It was unexpected to find the gauge narrower back in 2020, however the rail head profile may have been more worn in these areas, on more flexible wooden sleepers, hence SW-type carriages were able to be more tolerant of this narrower gauge. The wider gauge would have been most likely due to wooden sleepers with more movement whilst be measured under load by the EM80

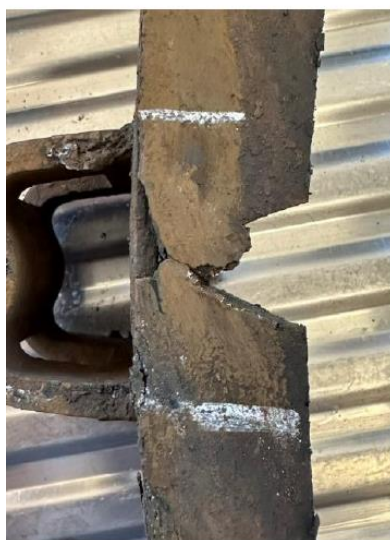
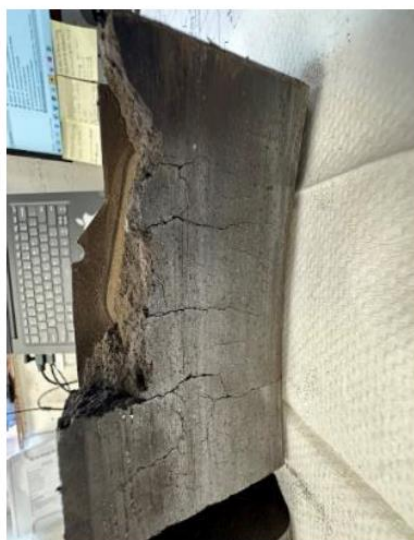
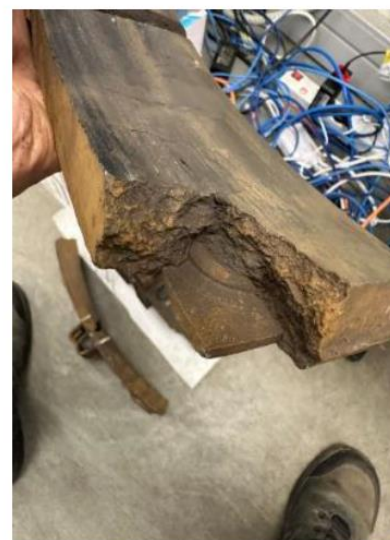
Issues affecting carriages: Brake Blocks

Brake blocks from myriad carriages; the failure mode is new

Since hunting was first reported in SW-type carriages in 2022, there has been an increase, in their wear liners and brake block failures. The lateral movement of the wheelsets is also evident with increased “fretting” between metal-to-metal contact points (see Table 1 and Appendix C - SW-type increased maintenance photos). Table 1 also reveals that in 2024 those carriages with the majority of 995 back-to-back or a C2 profile have all had work done, possibly due to them operating within C1 or 997mm train consists and having increased vibrations transfer between carriage types. Overall, between 2020 and 2024, average work orders for the 995mm back-to-back are lower. There has also been no change in the suppliers or specifications of wear liners or brake blocks during this time.

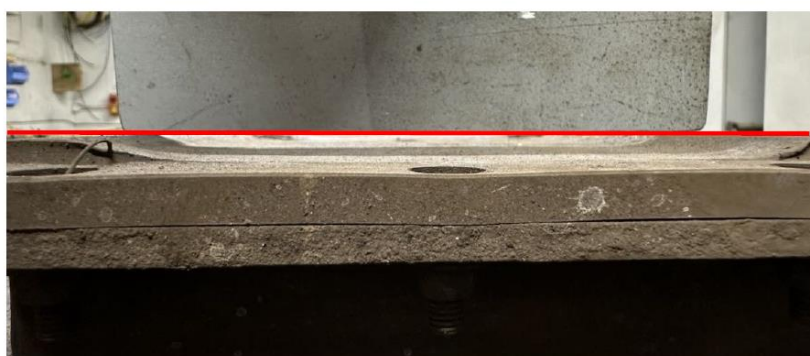
Issues affecting carriages: Wear Liners

Worn wear liners with a very rough finish. Normally they are smooth and evenly worn

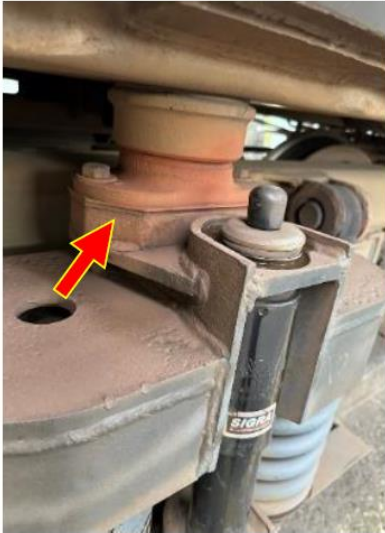
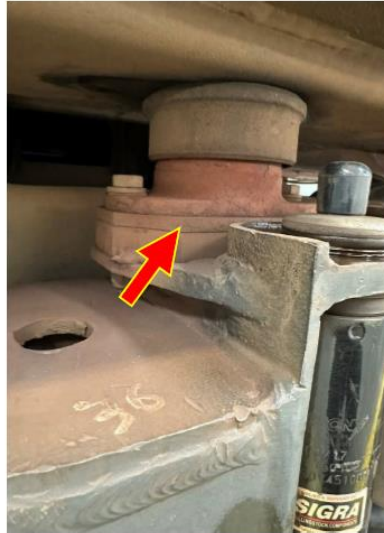
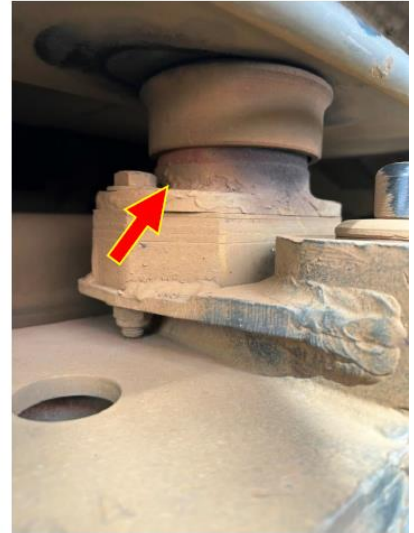
Issues affecting carriages: Side bearer

Red-coloured side bearers being found across the fleet.
The red is indicative of iron fretting

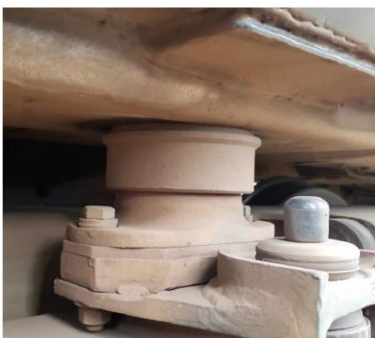
Issues affecting carriages – SWS3394 This car has a #2 profile

The bogies on SW3394 show much less evidence of fretting

- Hunting in SW type carriages looks less likely to occur when wheel profiles are C2 or C3 (narrower flange widths), as the rail wheel interface gap is improved with no change in conicity (also see Appendix C - Differences between C1 and C2 asset condition).

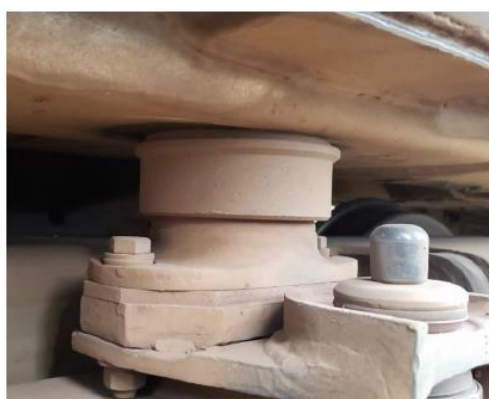
SW3394

Issues affecting carriages – SWS3394 Comparison with another car

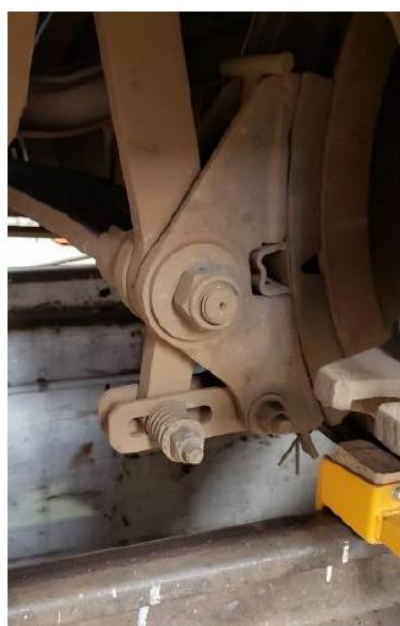
SW3394

Issues affecting carriages – SWS3394 Comparison with another car
